Manhole Inspection Summary

Manhole # S190__013MH

Location Address: **600 s pulaski st**

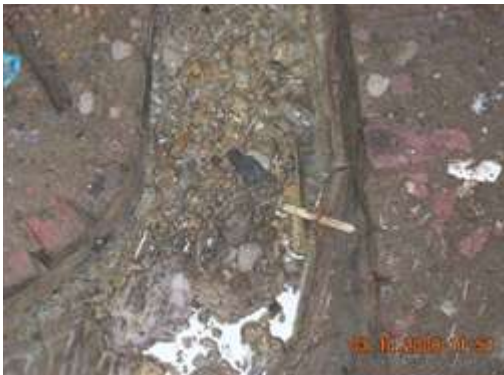
Defect 1

Condition: ☐ Sound ☐ Cracked ☐ Root Intrusion ☐ Deteriorated ☐ Leaks ☒ **Debris**

debris in channel

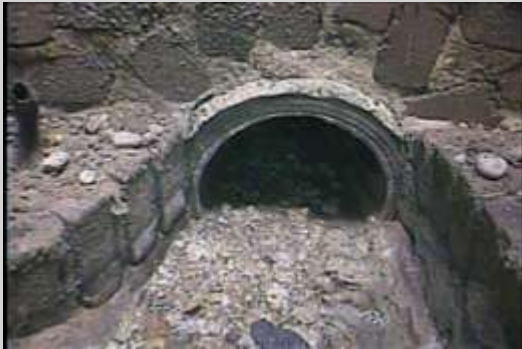
12 O'Clock Outflow

8 in. Circular Gravity Sewer
Pipe Out @ 12 O'Clock

Pipe Height: **7.2** (in.) Rod and Bar (Angled)
Pipe Material: **Clay** ☐ Pipe Lined
Invert Depth: **6.66** (ft.) Flow Characteristics: **Slow**
Deposits: ☐ None ☒ **Mud** ☐ Sludge ☐ Debris ☐ Grease
Silt Depth: **3** (in.) Deposits Extent: **Light**
Infiltration: **None** Pipe Seal Cond: **Sound**

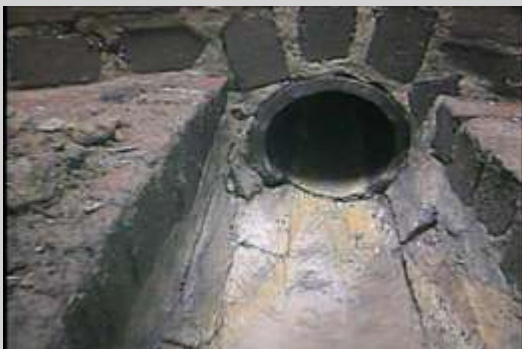
9 O'Clock Inflow

6 in. Circular Gravity Sewer
Pipe In @ 9 O'Clock

Pipe Height: **6** (in.) Rod and Bar (Angled)
Pipe Material: **Clay** ☐ Pipe Lined
Invert Depth: **6.49** (ft.) Flow Characteristics: **Slow**
Deposits: ☒ None ☐ Mud ☐ Sludge ☐ Debris ☐ Grease
Silt Depth: **0** (in.) Deposits Extent:
Infiltration: **None** Pipe Seal Cond: **Sound**
